BRISTOW LAKE DAM

CRAWFORD COUNTY, MISSOURI

MO 30985

PHASE 1 INSPECTION REPORT NATIONAL DAM SAFETY PROGRAM

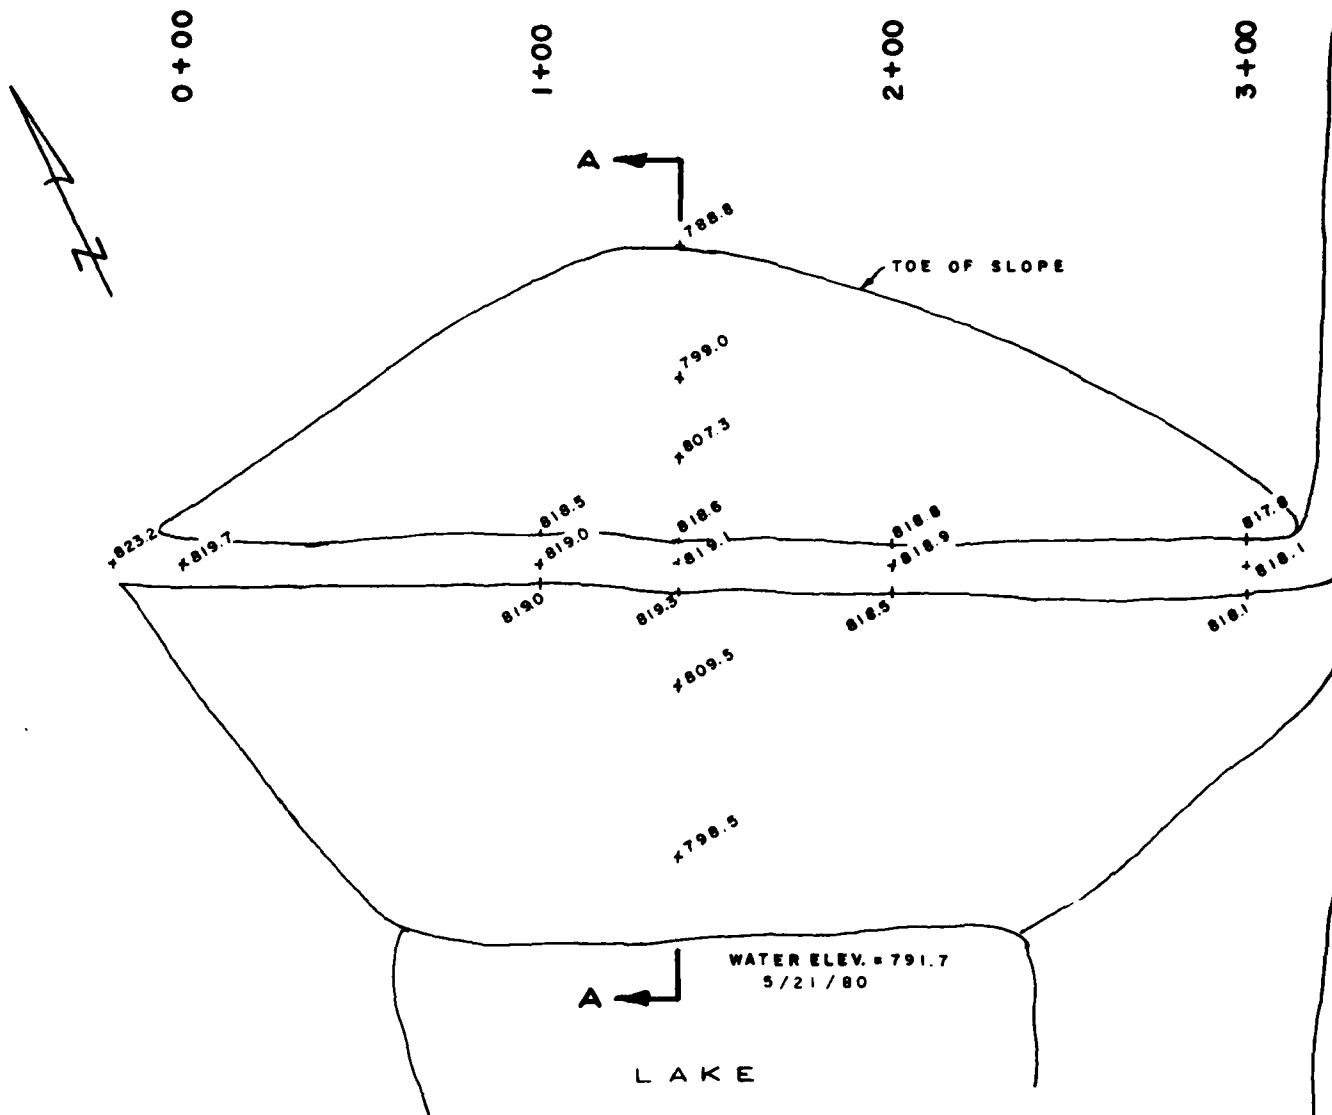
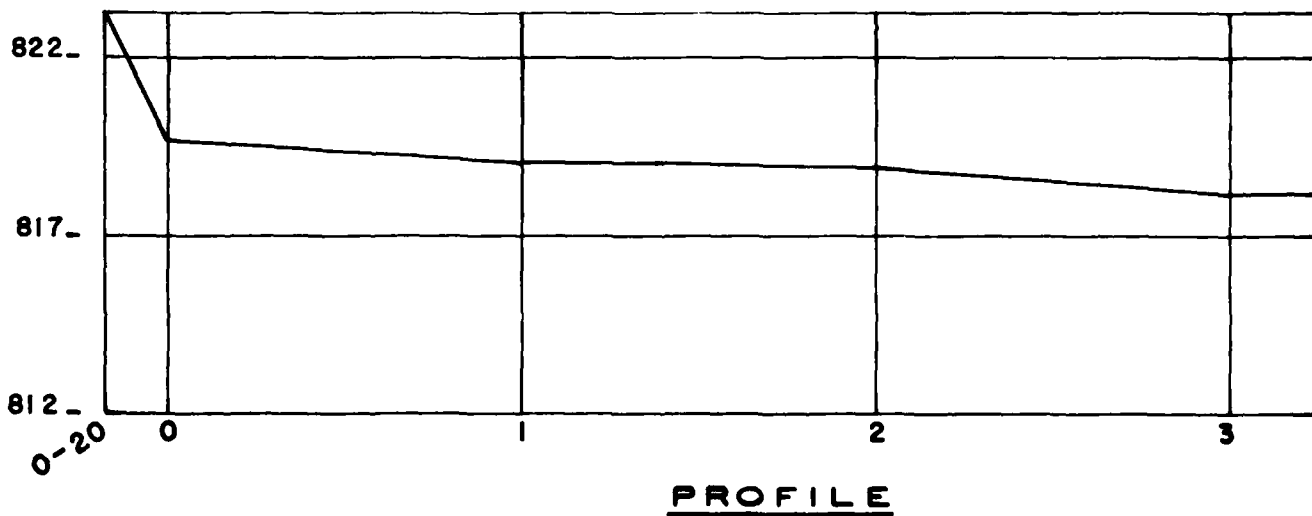
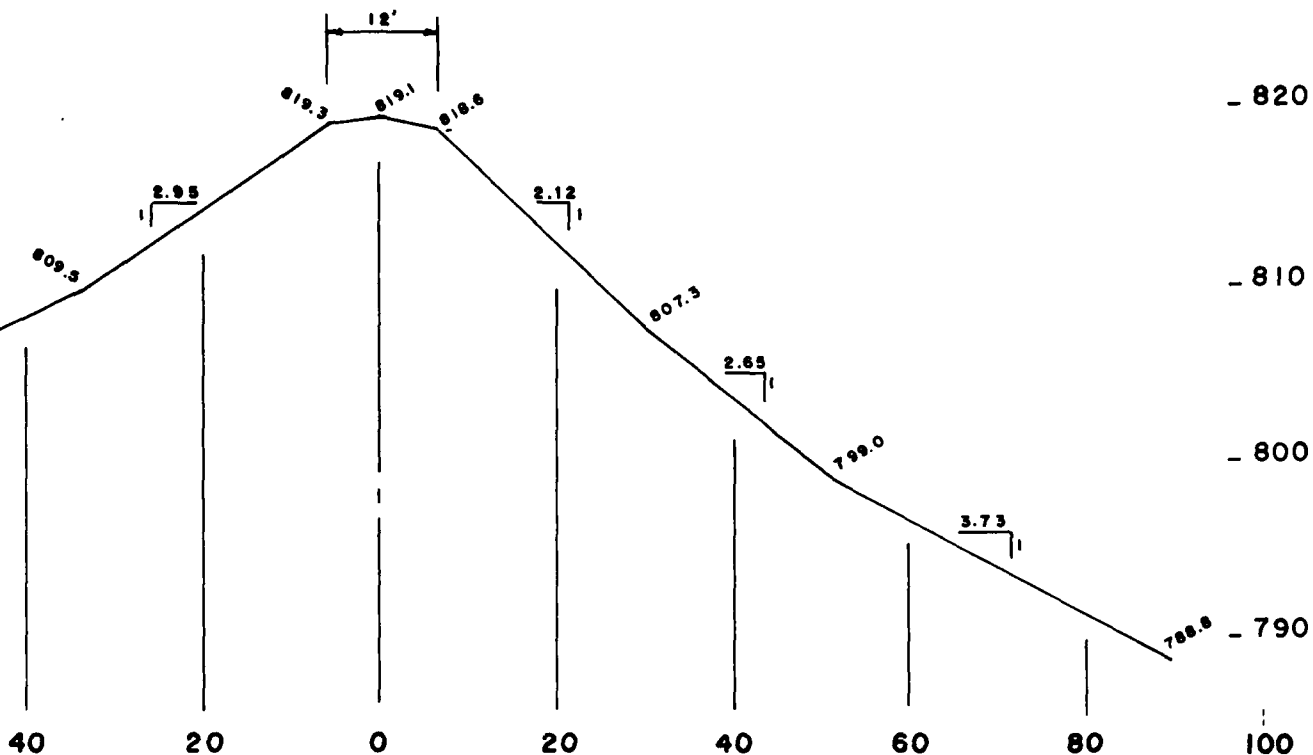
SHEET 3 APPENDIX A

The dam appears to be in good condition. The upstream face had some scattered small trees and brush. The slope is relatively flat (see Sheet 3 of Appendix A), and there was no sloughing or significant erosion. There was no riprap protection (see Photo No. 14).

The horizontal alignment of the crest appeared good, and no surface cracking or unusual movement was obvious. The crest slopes from the left to the right abutment (see profile - Sheet 3 of Appendix A). It is not known whether it was constructed this way, or if some settlement has occurred (see Photo No. 3).

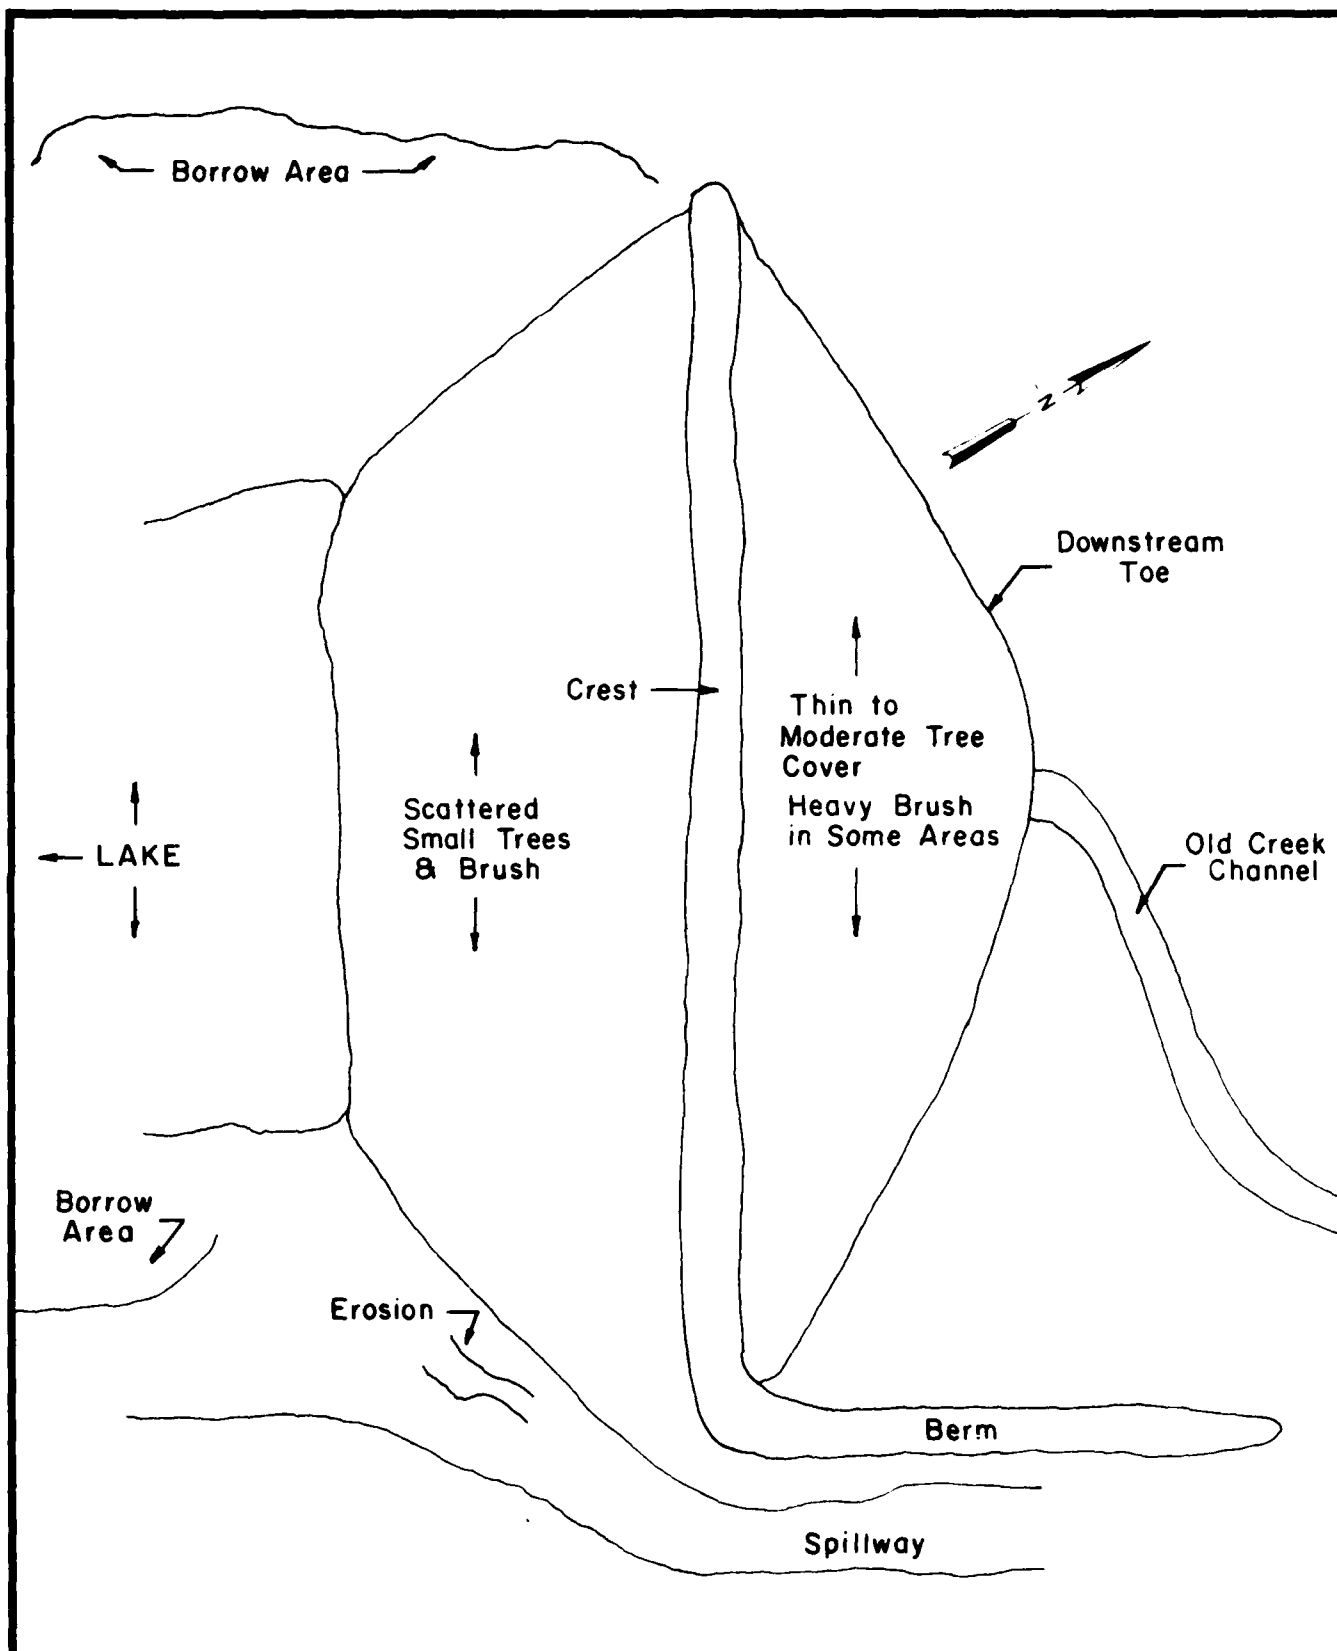
PLAN SKETCH OF FEATURES

The downstream face was thinly to moderately covered with trees and brush with some animal burrows noted. No sloughing or serious erosion was evident on the embankment or at the embankment-abutment contacts. The valley and the original streambed were investigated for a distance of about 200 ft downstream of the dam for signs of seepage, but none was found (see Photos 5 and 6). Sheet 5 of Appendix A presents a plan sketch of the dam showing observed features.
